Asbestos bags used as carpet underlay and pipe lagging

This Alert highlights concerns with hessian bags, previously used to transport asbestos, being used in carpet underlay and pipe lagging.

January 2010

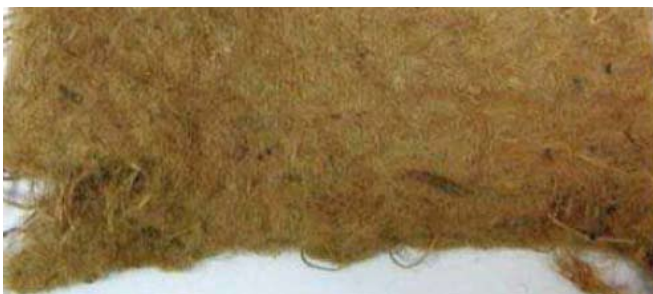
Carpet underlay or pipe lagging, made from hessian bags potentially contaminated with asbestos, is likely to be brown in colour and look like a fibrous mat. The carpet underlay may also be significantly compacted due to 30 years plus of wear.

The carpet underlay may look similar to above picture (courtesy of Department of Health, Western Australia).

1. Before commencing any removal or repair work, consider whether the carpet underlay or pipe lagging may contain asbestos contaminated hessian bags. For example, was the carpet underlay/pipe lagging installed prior to 1980?
2. If yes, arrange for a competent person (ie a person with training, experience and knowledge in identifying

asbestos containing material and able to determine risk and appropriate controls) to visually inspect the carpet underlay or pipe lagging. For more information on competence of people identifying asbestos, refer to WorkSafe's Compliance Code, *Managing asbestos in workplaces*.

3. If, as a result of steps 1 and 2, the carpet underlay or pipe lagging is suspected to contain hessian bags, you may either assume asbestos to be present or confirm this by arranging a competent person to take a sample and have it analysed by a laboratory accredited by the National Association of Testing Authorities (NATA). A list of accredited laboratories is available at nata.asn.au

4. Where asbestos is assumed or confirmed to be present in the carpet underlay or pipe lagging, you must arrange for its removal using a 'Class A' asbestos removal contractor. See WorkSafe's Compliance Code, *Removing asbestos in workplaces* for more information. A list of licensed 'Class A' removalists is available at worksafe.vic.gov.au

5. The area can only be reoccupied once asbestos containing material has been removed and a clearance certificate by a competent person (must be independent from the asbestos removal contractor) has been issued. The clearance certificate must state the asbestos removal area (and the area surrounding it) has been cleared of asbestos and is safe to be reoccupied.
